Manhole Inspection Summary

Manhole # S05UU1020MH

Location Address: **5619 HIGHGATE RD**

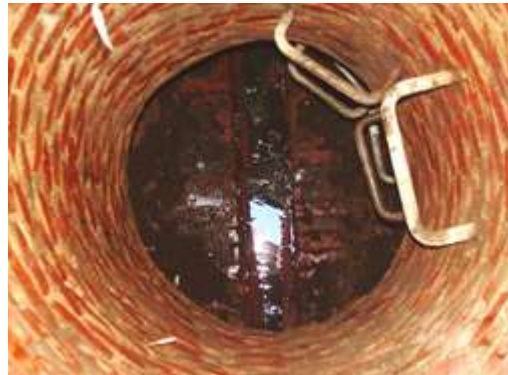
Top View

Bench ☒ Exists Material: **Brick** ☐ Parged ☒ **Debris** (not Condition related)

Surcharge ☒ **Evidence Of Surcharge** Depth: **1** (ft.) ☐ Active Surcharge Present

Evidence of surcharge - Bench debris.

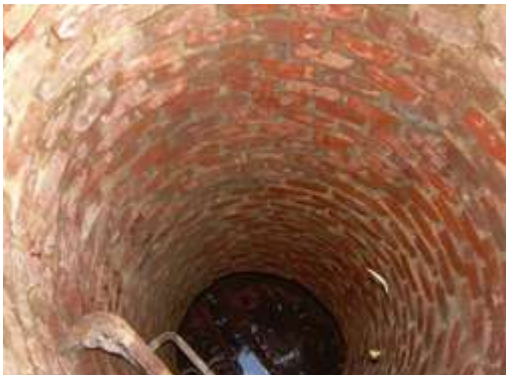
Defect

Infiltration: ☐ None ☐ Joint ☐ Cracks ☒ **Mortar** ☐ Roots ☒ **Wall**

Barrel infiltration.

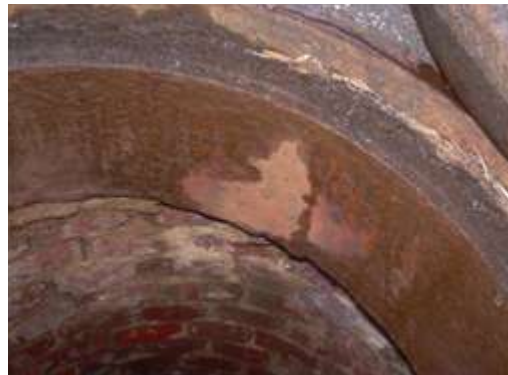
Defect

Frame Offset: **0** (in.) Condition: ☐ Sound ☐ Cracked ☒ **Leaks**

Infiltration: ☐ None ☒ **Joint** ☐ Cracks ☐ Mortar ☐ Roots ☐ Wall

Frame leaks. Corbel infiltration.

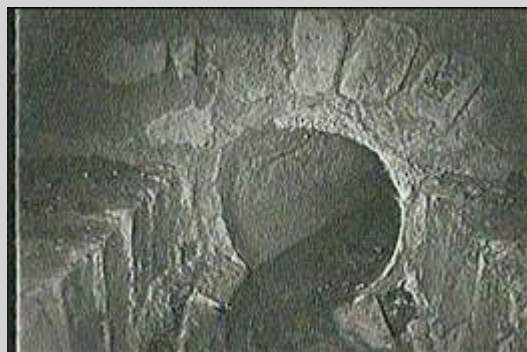
Pipe Out @ 12 O'Clock

Condition: ☐ Sound ☐ Cracked ☐ Root Intrusion ☒ **Deteriorated** ☐ Leaks ☐ Debris

Channel deterioration.

Infiltration: **None** Pipe Seal Cond: **Cracked**

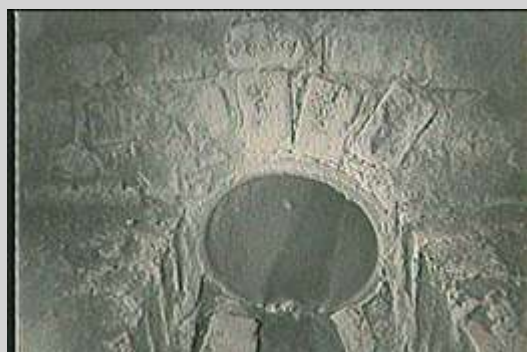
Pipe In @ 6 O'Clock

Condition: ☐ Sound ☐ Cracked ☐ Root Intrusion ☐ Loose Brick ☒ **Deteriorated**

Barrel deterioration and infiltration.
